# FireOpsOnline.com

### Windows, Doors and More

by Deputy Chief Michael Terpak

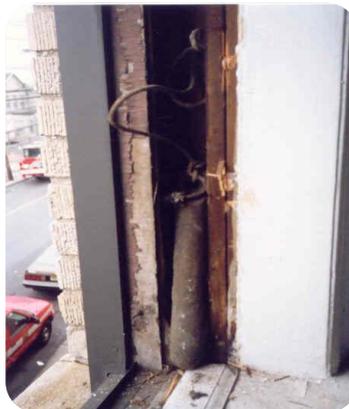
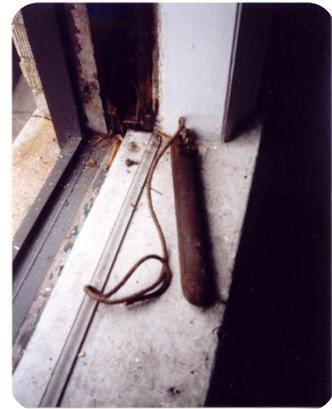
Window ballast pockets: Window ballast pockets can be found in old double-hung wooden sash window enclosures. If an older window is still in use, a clue of a window ballast pocket will come from the presence of a rope or chain lining the inside of the windows track. Pieces of rope or chain were often fastened to cast iron weights that were hidden within pockets on the sides of the window frame. This tubular shaped piece of cast iron was designed to slide up and down within the pockets to counter the weight of the windows slide allowing the window to stay open.

The cast iron weight averages around 2" in diameter, 10" in length, and can weigh as much as five pounds. The weights design and shape allows it to ride up and down in the vertical channel or pocket for the entire height of the window. In many older buildings, renovations have replaced the older wooden window sashes with newer and smaller replacement windows.

Replacement windows; however, are often installed within the same opening as the older window leaving the original voids or pockets still in place. For ease and speed with the new window installation, window installers have been known to cut the rope or chain attached to the older wooden sash windows, allowing the ballast weight to fall and remain in their original pockets. This practice allows the older wooden sash windows to simply be removed making room for the new and smaller window to be installed within the existing opening. But as new and solid as the new window replacement will appear, if fire compromises any of the new decorative wood trim that wraps around it, the original void space will allow fire to travel in and behind the structures walls.

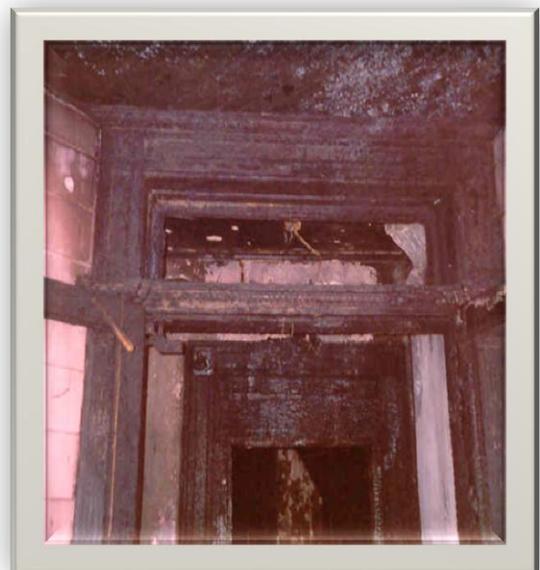
Transoms: Transoms are small windows designed and installed above a door or window opening. Their original intent was to allow light and possibly air into a room. They are most commonly found in older frame dwellings, schools, row frames, multiple dwellings and brownstones; however, you may also find them in newer and modern homes and offices due to their aesthetic value and appearance.

In many older installations, homeowners may have restored their use appearance to add to the home's decor. But as decorative as some may appear, they present a significant concern to firefighting forces. With older transom designs, all that prevented fire from penetrating the opening was a single pane of glass. Also in older designs, transoms openings were mounted on hinges to allow airflow. Opening and closing of the transom was accomplished by pulling on a chord or decorative chain. If left open, or if the

hinge mechanism failed or was damaged, smoke and eventual fire would penetrate the opening sooner.

What caused a great concern to fire fighters years ago and still to some degree today was a transom opening installed over an apartment door in a multiple dwellings. As fire spreads throughout an apartment in a multiple dwelling, the single pane glass in the transom would quickly fail, allowing fire and smoke into the public hallway. Over the years, city fire codes required the openings to be covered by plywood or sheetrock/gypsum. But as the years pass, these coverings can become compromised and present the same dangers they did years ago.

My mentor from Ladder Co.12 advised to me to take a quick look at the condition of the transom openings on the fire floor, especially when we were assigned to search the floor above the fire. He stressed the importance of being aware of these designs, and said, *"If they fail before the engine company has water on the fire, the staircase will become compromised requiring us to have additional means of egress sought out, so let's be prepared."* Sound advice I still pass on today.
